Manhole Inspection Summary

Manhole # S37G__023MH

Location Address: **water st**

Cross Street: **commerce st**

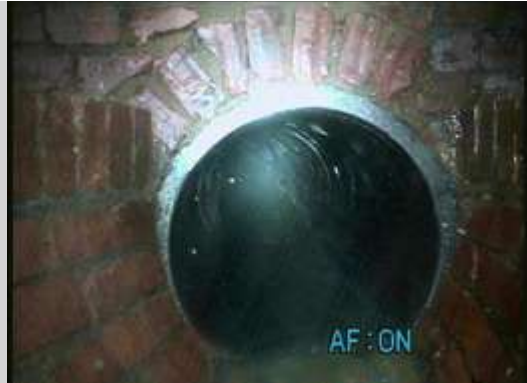
12 O'Clock Outflow

15 in. Circular Gravity Sewer
Pipe Out @ 12 O'Clock

Pipe Material: **Clay** ☐ Pipe Lined

Infiltration: **None** Pipe Seal Cond: **Unknown**
